REQUEST FOR CORRECTIVE ACTION

Truck Model: P152,
Serial Number: P152L 0170 12020
0171
0172
0173
0175

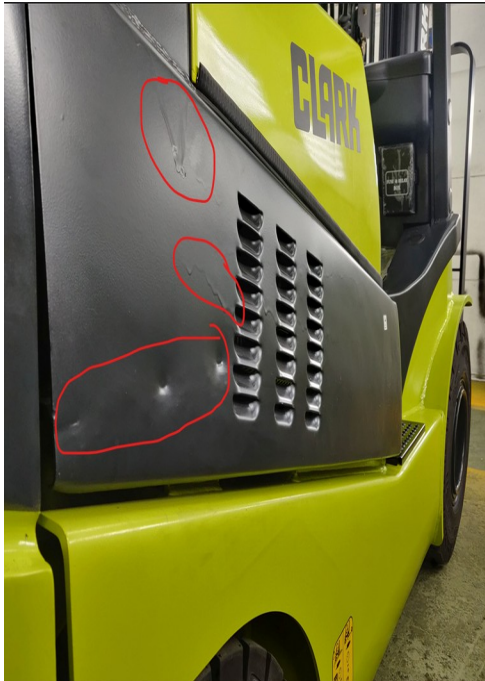
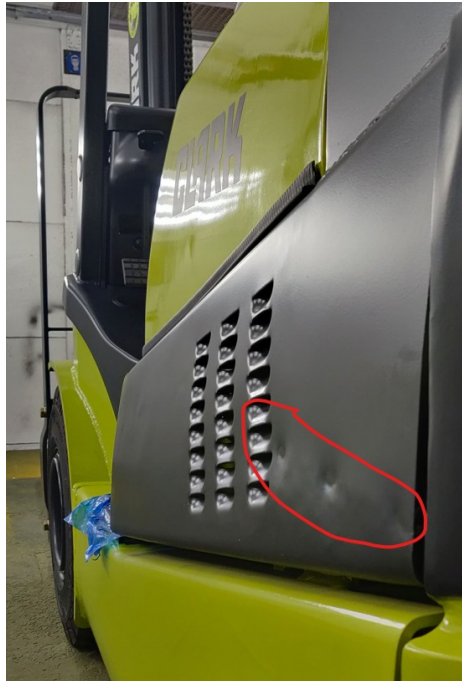
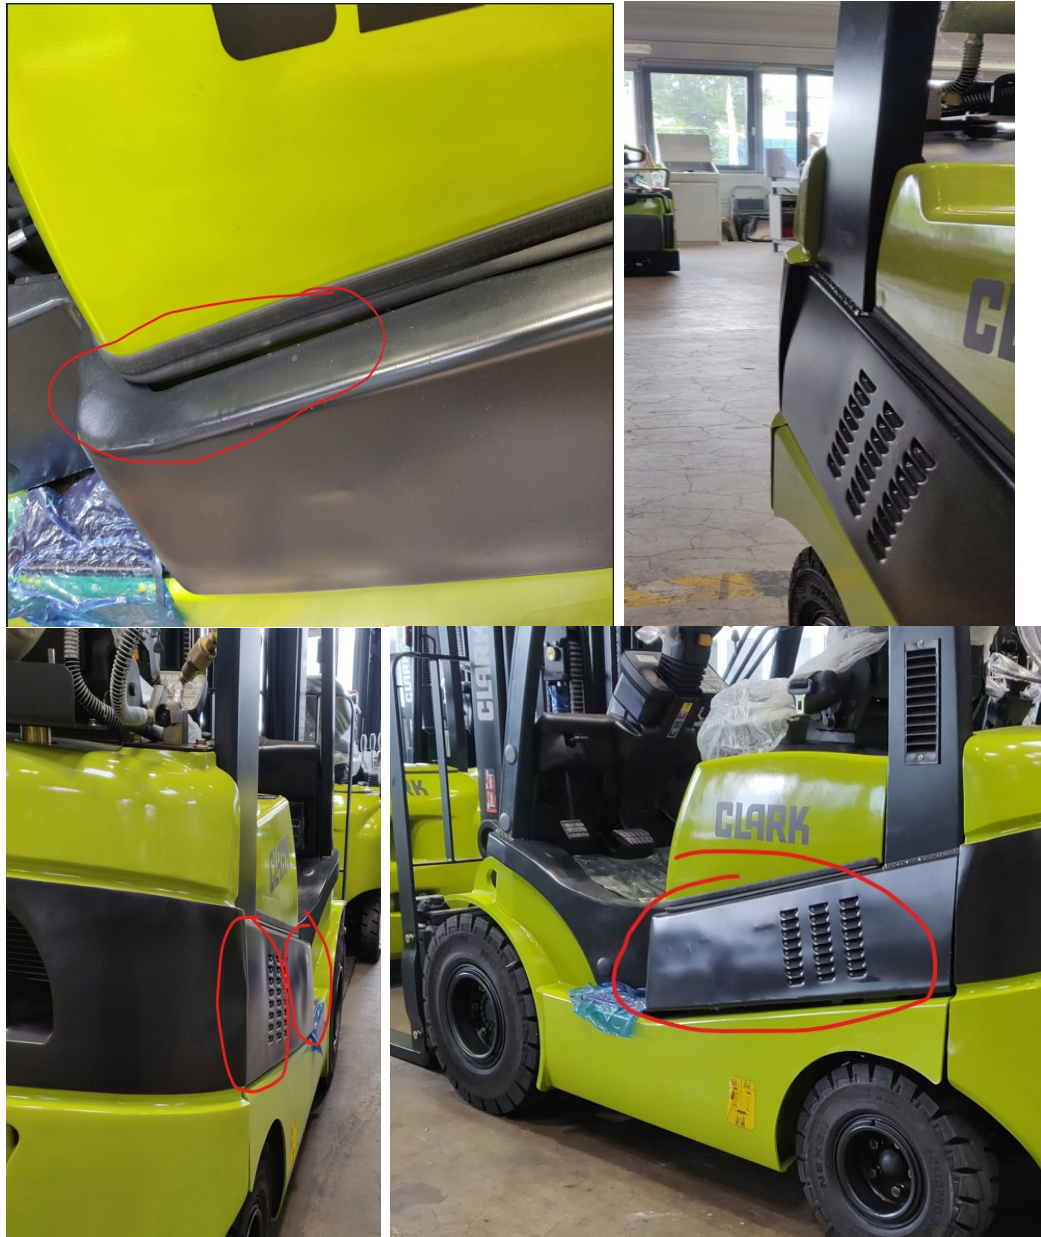
The Overhead Guard (OHG) on the trucks show

1. Deformation

Training needed for the workers at the OHG manufacturing and painting facilities.

Quality assurance of OHG welding and painting needs to be improved.

Please send urgently 5 replacement OHGs in good quality. Rolf Eiten wishes to get these replacement OHG with air freight as soon as possible, as the customers are waiting for their trucks.

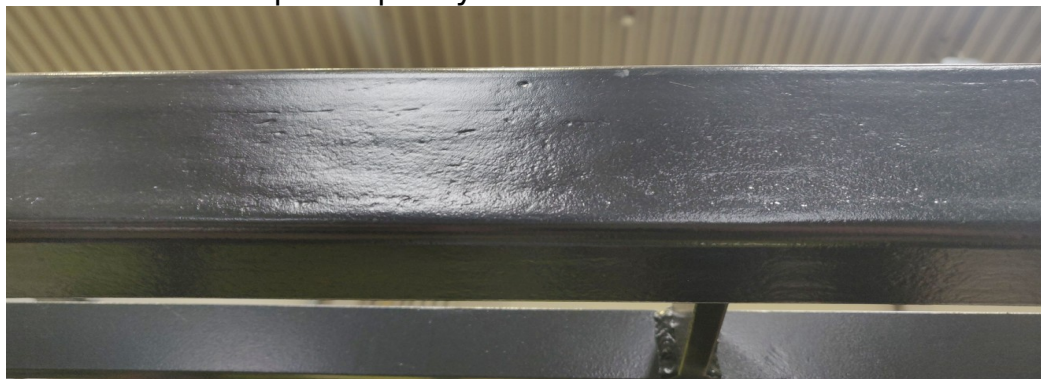
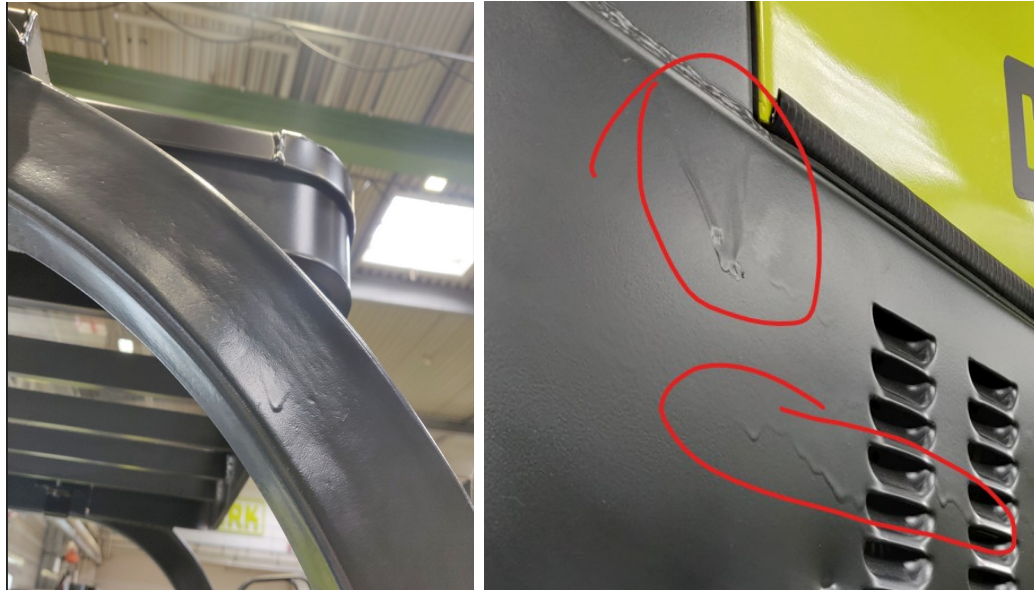
2. Poor surface and paint quality

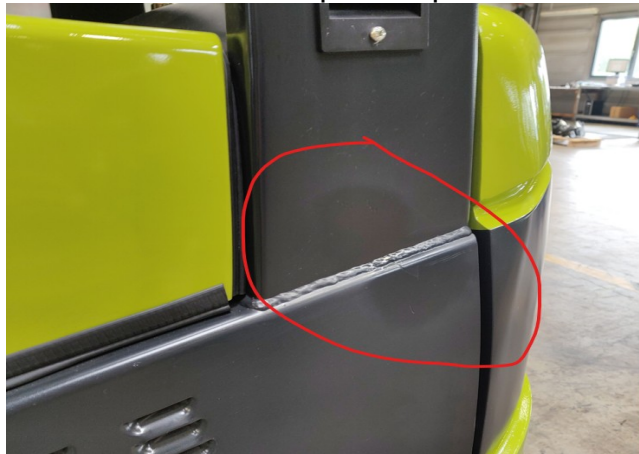
3. Obvious areas of repaired paint
